**Jilkoot example: Beach Road** Our first stop after getting off the ferry on Friday, 20220916 was at the catastrophic [Beach Road Land Slide](#) (BRLS). It's been intensively studied by an interagency team including our friend Jim Baichtal, co-author on a great multidisciplinary summary published earlier this year.

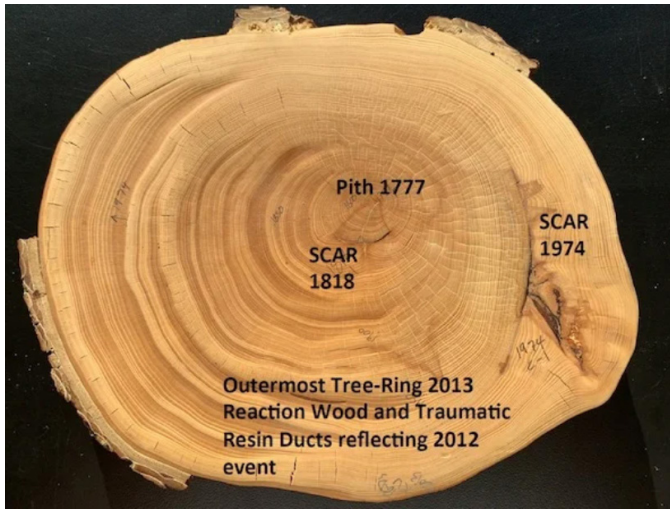
Tree cross-section from one of the avalanche paths around Juneau showing scars from avalanche events in 1818, 1974, and 2012. Credit: Daniel Stahle

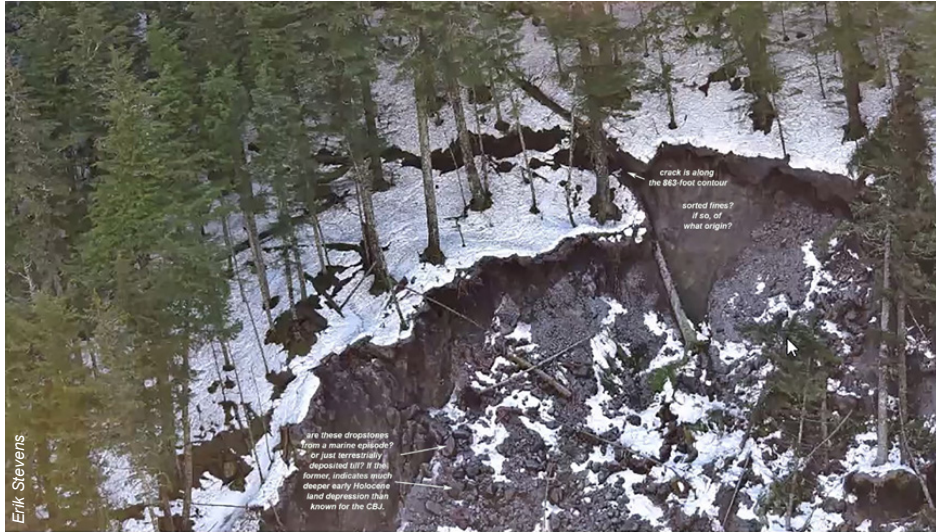
Avalanche forecaster Erik Stevens flew the head scarp immediately after the landslide and took the most revealing image we have, below. (20220920: *I'd hoped for some drone aerials on our Chilkat tour, but this site is in a no-fly zone due to proximity to the airport.*)

Forest at this headwall looks like small, fairly even-aged hemlock. Probably not old growth. Photo-resolution's not good enough in my copy to identify the smooth sediments in the head scarp. If it's marine, that's way above highest marine deposits so far documented by Norton & Baichtal in Greater Chilkat Watershed.

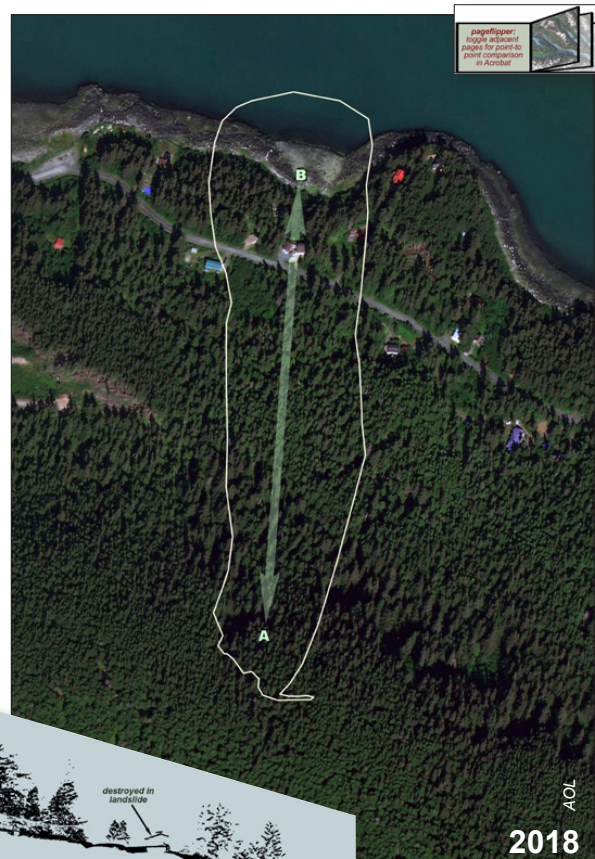
**Right:** 5th of 8 pageflippers. In 2018 imagery, a band of smooth textured forest extended cross-slope uphill. Then, where slope steepened, larger, gappier forest grew. Thanks to LiDAR, we have a detailed record of this forest's structure.

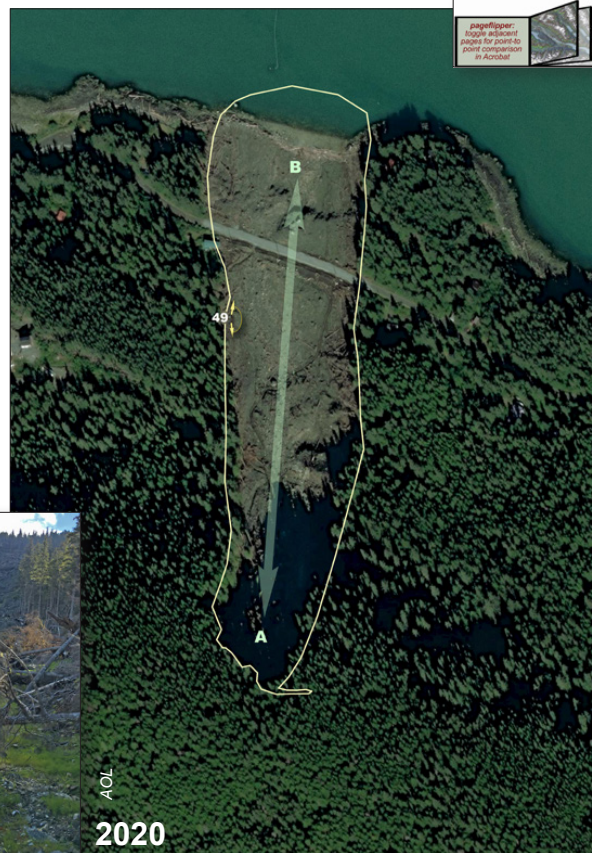
6th of 8 pageflippers. In summer 2020 there was almost nothing growing in the fresh scarp, at least not visible from this elevation. Arc from photo-point 49 shows span of iPhone sweep-pano, below.

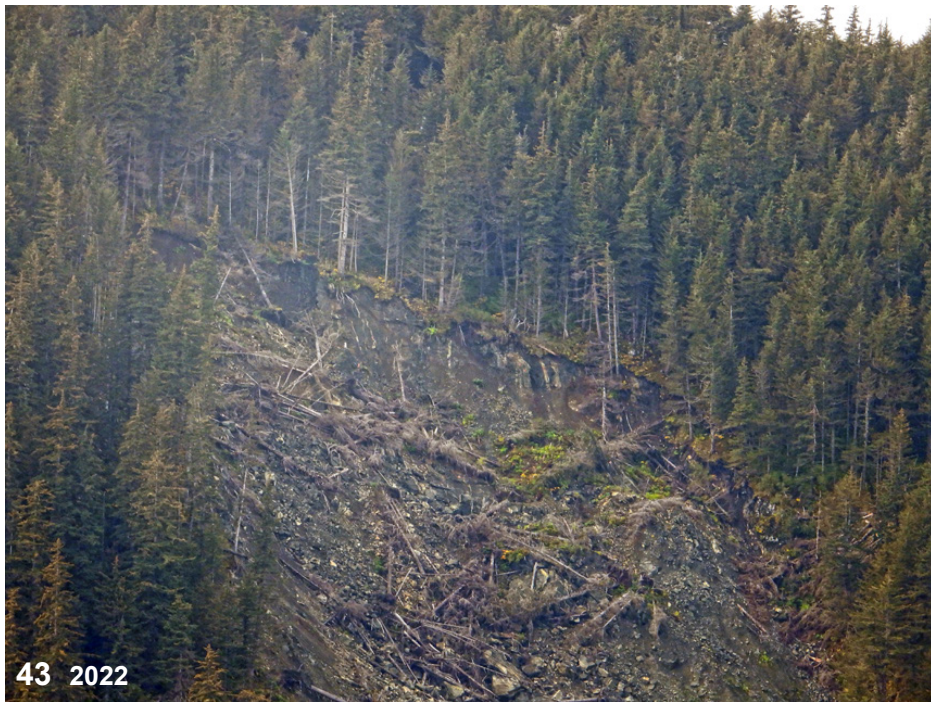
Still requiring heavy retouching in Photoshop to bring up detail from the nearly backlit image, this telephoto from in-bound ferry at least shows fines in the headscarp, and still-unsettled debris-dams, poised to flush more soil downslope. Presumably in 'whimpers' not 'bangs'? Encompassing forest looks quite even-aged.

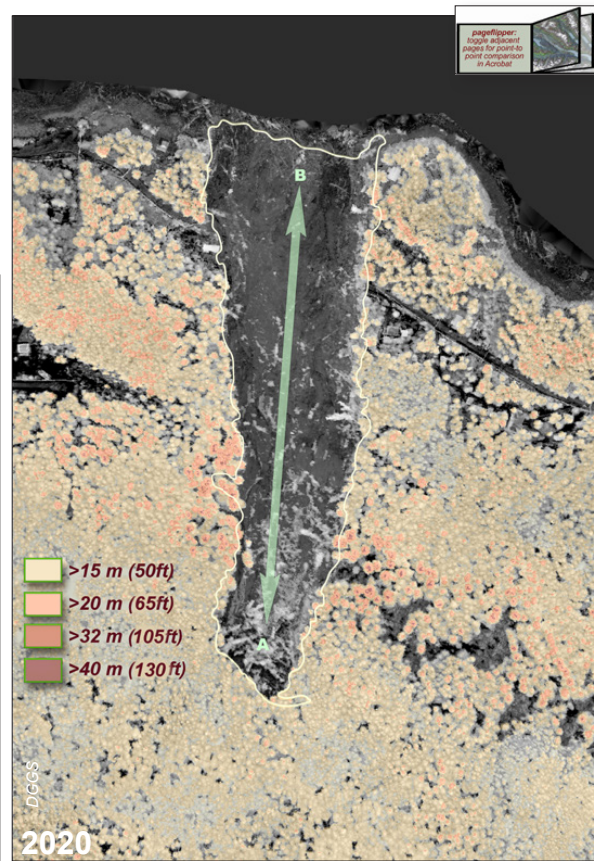
Last of 8 pageflippers. DGGS portal offers both DTM (bare earth, or ground), and DSM, (including vegetation surface). Subtracting DTM away from DSM gives canopy height. Tallest trees frame the upper (southern) end of the transect. By standards of my homeland in Áak'w and T'aakú Aani, where some Nettleslide-framers reach 200 feet, these are not super-trees. But size is relative, and that gappy colluvial patch just east of BRLS headscarp with lots of brick-tinted crowns >140 feet is Jilkoot's answer to Áak'w's cliffhanging Landmark Trees.
