**Jökulhlaup 2023**  
erosion below backloop bridge  
*Richard Carstensen • Discovery Southeast*

## 20230810 Affliction on alluvium

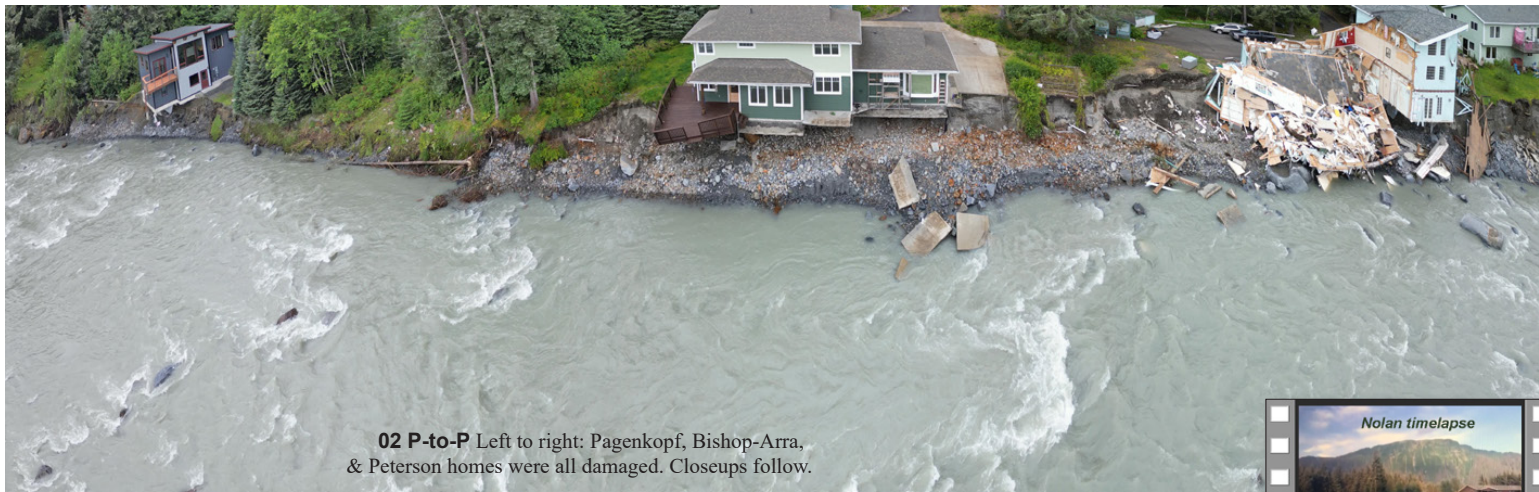
**02 P-to-P** Left to right: Pagenkopf, Bishop-Arra, & Peterson homes were all damaged. Closeups follow.

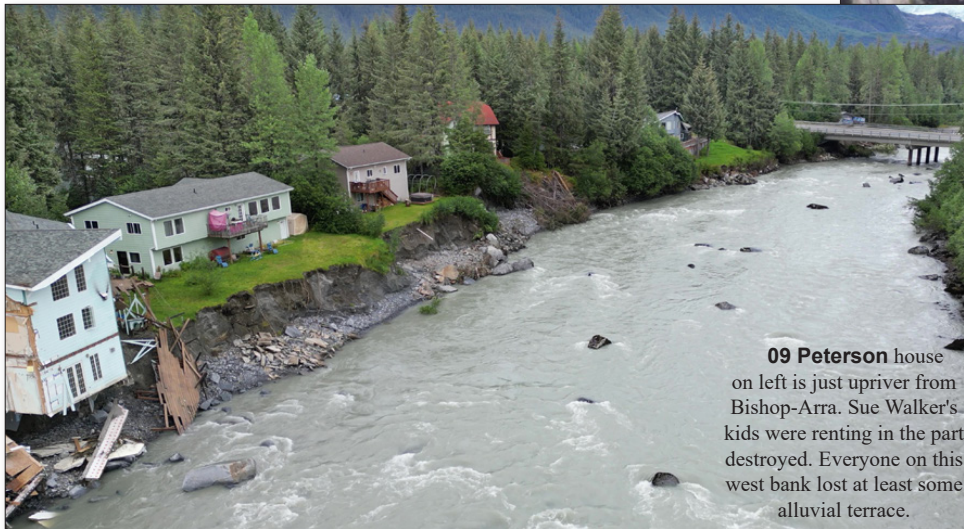
**09 Peterson house** on left is just upriver from Bishop-Arra. Sue Walker's kids were renting in the part destroyed. Everyone on this west bank lost at least some alluvial terrace.

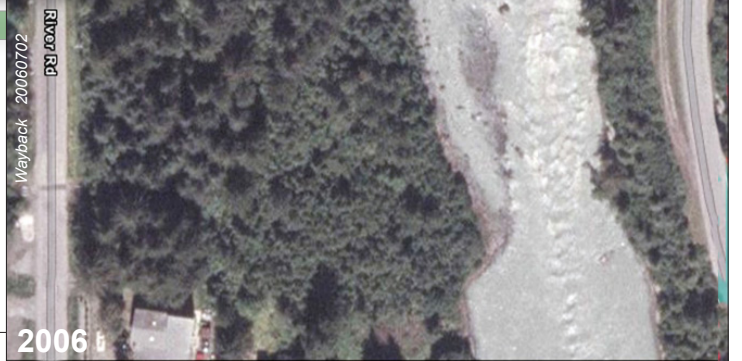
**Right: Pageflipper 1 of 5:** No development yet on Bishop subdivision. Seems that water alone can't move car-sized rocks, so largest boulders have been in place since glacier dropped them, mid-1700s.  
<sup>1</sup> Did this flood budge them? Dan Kirkwood has rafted this reach, and thinks some *did* move.

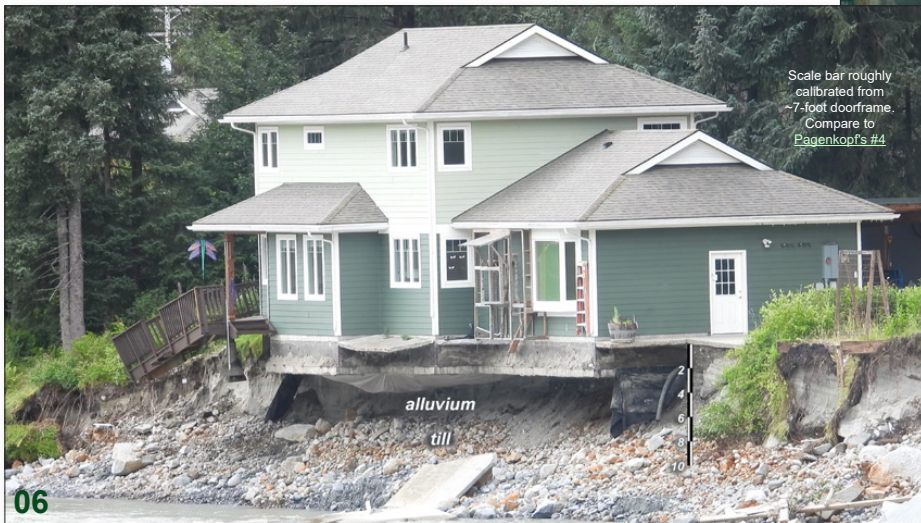
Checking in with Nate Bishop's sister Brita on 0806, I learned that an army of friends had already cleaned out the house. By 0807, Wooch Eel'óox'u héen was back down to normal summer highflow, and I drove out for a look. Those 20 minutes on-site propagated into days of hydro-homework and cartographic storytelling. Rivers and lake-burps and glacier-tracking are suddenly more interesting than even mountain goats :) Seems like this natural historian's take on what happened might count for my version of 'showing up,' however sweatless or virtually.

**06 Nate's from bridge** By 0809, stout builder-friends and calloused hands had dragged those fallen

cement slabs under the cantilever, to serve as temp-footings for jack-up posts. Maybe will buy some time until next year's burp.

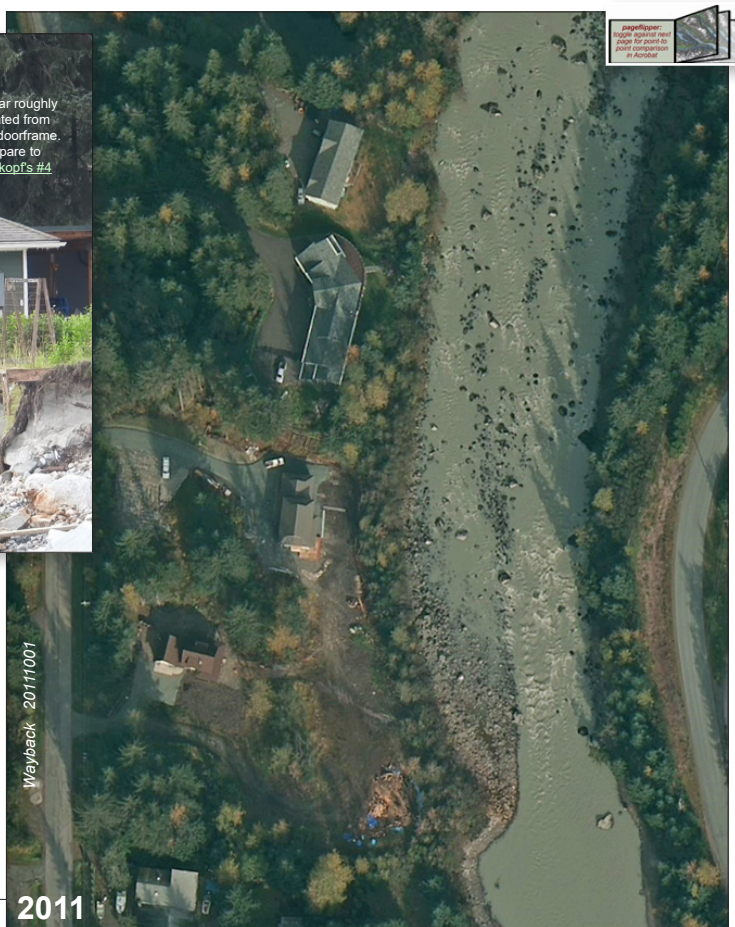
**Pageflipper 2 of 5:** Compare rocks to the other low-water aerial in 2023.

Cutbanks exposed in above view are sorted fines about 6 feet deep. Is there a sudden switch to large-boulder till below that? On this 2011 aerial, exposures in riverbed off (future) Pagenkopf's corroborate. Terminal moraine is 500 yards down-river, on the lot where freshly-built Riverside Condos are causing owners to re-assess whether it's karmically wise to name your home for proximity to a home-wrecker.

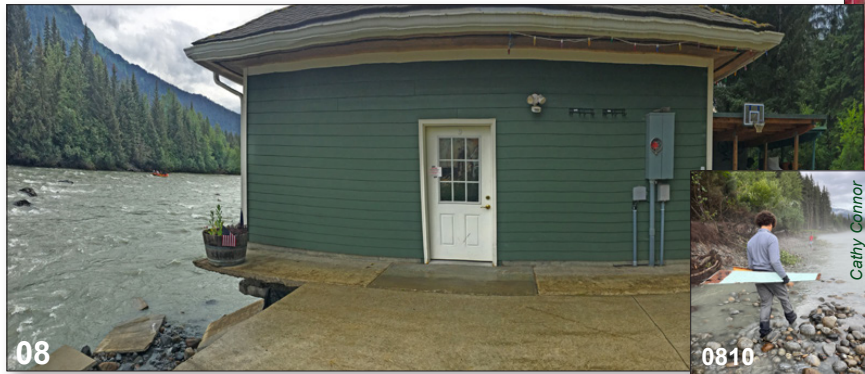
**08 Slabs** Downriver pano from north wall, 0807. ABAK already floating by against far bank.

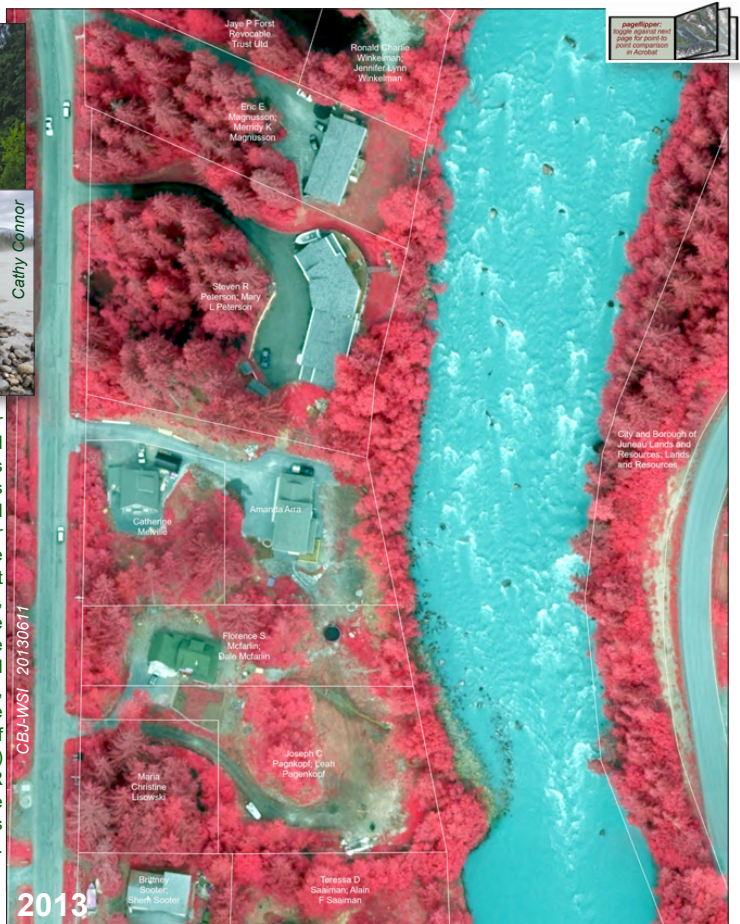
**Pageflipper 3 of 5:** City's orthos for our wetland surveys. Color infrared tells darker, starry-branched spruces from 'lumpier', brighter deciduous alder. When leaves have dropped we can get better ground detail for post-flood orthos and SFM (structure from motion) terrain models. Not much change since preceding 2011s, except for addition of Catherine Melville's home on roadside lot above Nate & Amanda's. She's relieved *not* to have a riverview this week, although I suppose that could change by the time she's my age. (Sooner, if Suicide lake-burps keep intensifying?) This mission coincided with LIDAR acquisition, from which I created bare earth topography with 1-foot contours on next page.

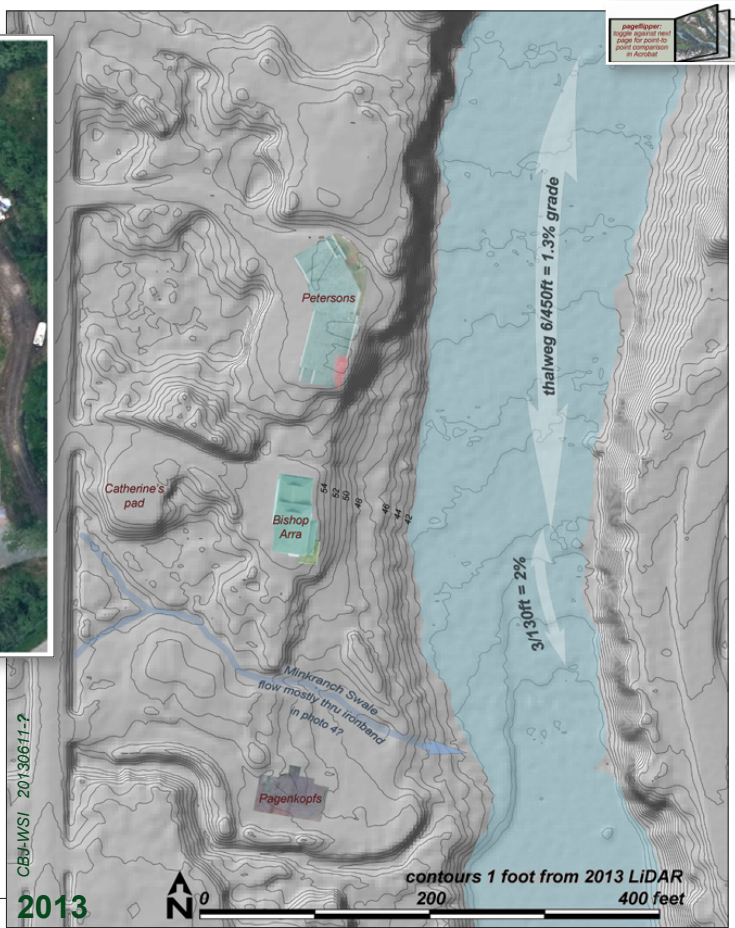
**Pageflipper 4 of 5:** In 2013, Bishop-Arras were ~13 feet above river level on the June DTM. LiDAR shows wave **surfaces**,\* but assuming consistent water depth, the thalweg (deepest part) dropped at ~1.3% from bridge to Nate's, then at 2% over a headward-cutting 'bite.' It'll be interesting to map the flood's enlargement of that bite. Comments follow on till and recent river evolution.

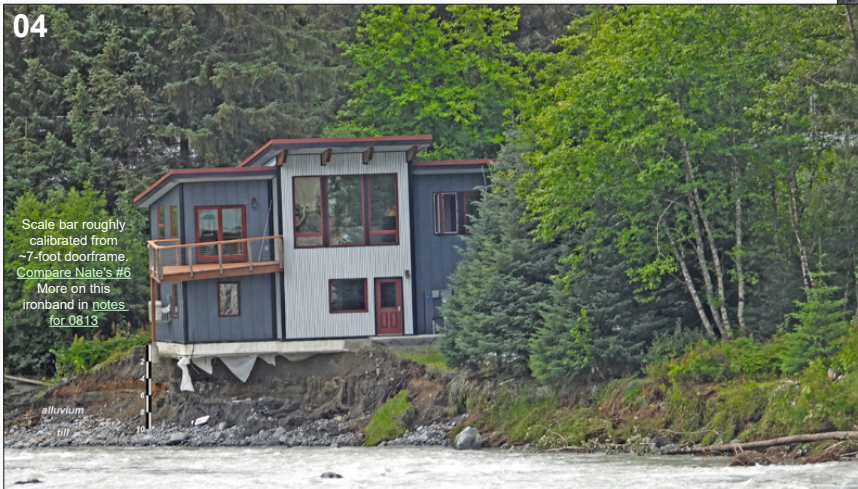
04

Scale bar roughly calibrated from ~7-foot doorframe. Compare Nate's #6. More on this ironband in notes for 0813

**04 Pagenkof's** Joe and Leah have the southernmost lot on the old Maier parcel that Nate purchased and developed through the 2010s. As with bridge-view of Nate's place (06), I've added a 10-foot scale bar against the fresh escarpment. Looks like the alluvium-to-till contact might be a couple feet deeper here. Halfway down is a 2-foot thick

irony stratum that probably results from groundwater movement through a more conductive bed, legacy of a time when outwash was trapped behind the ~1820 recessional. Judy Maier says that when her family first homesteaded here, before river incisement, a mink rancher up-slough could pitchfork spawners out of this tributary for his animals. Only a sludgy surface trickle remains,

full of iron flocc.\* Maybe Joe's redbed is where the majority of seepage through Minkranch Swale now drools into the river? <sup>2</sup>

**30 Pagenkopf substrate** I noted on [previous photo 04](#) that a reddish band indicated groundwater movement, probably through Minkranch Swale. Alluvium in this west-bank neighborhood could have originated from several directions. Just before I got to Joe's, this fresh collapse

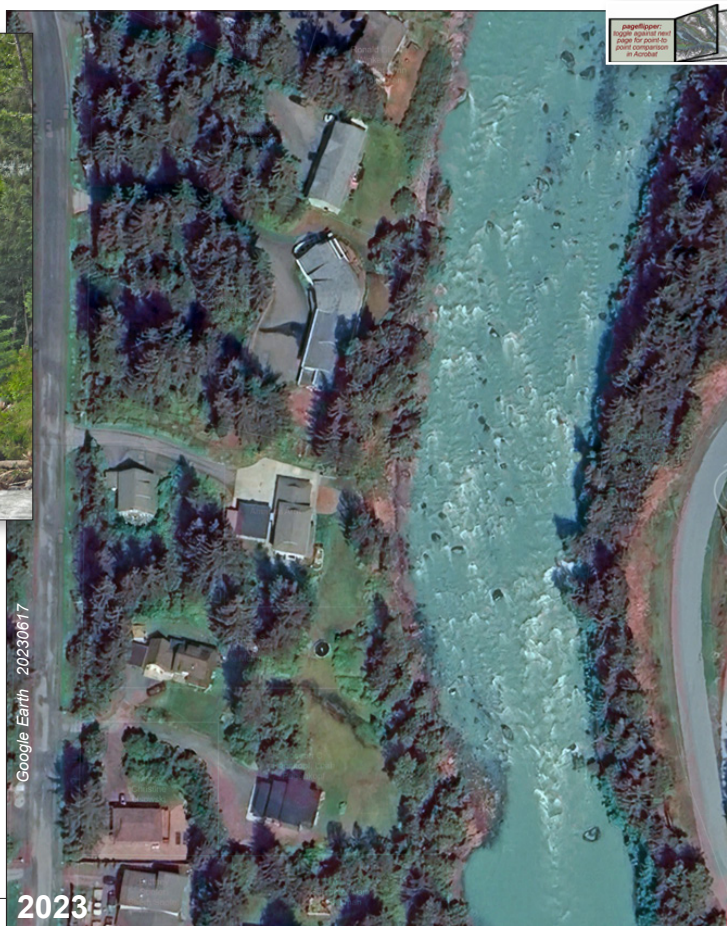
Google Earth 20230617

**Pageflipper 5 of 5:** Most recent online imagery from mid-June this year allows comparison of rock placement with even-lower 2011. No detectable rock displacement. Near bottom, that bulge in the bank is probably from a recessional that Lawrence never dated, halfway from 1765 to 1860. It deflected Minkranch Swale outwash toward center valley, beginning roughly 1820. Unfortunately for Joe and Leah, the top ~8 feet was not resistant till but exportable alluvium.

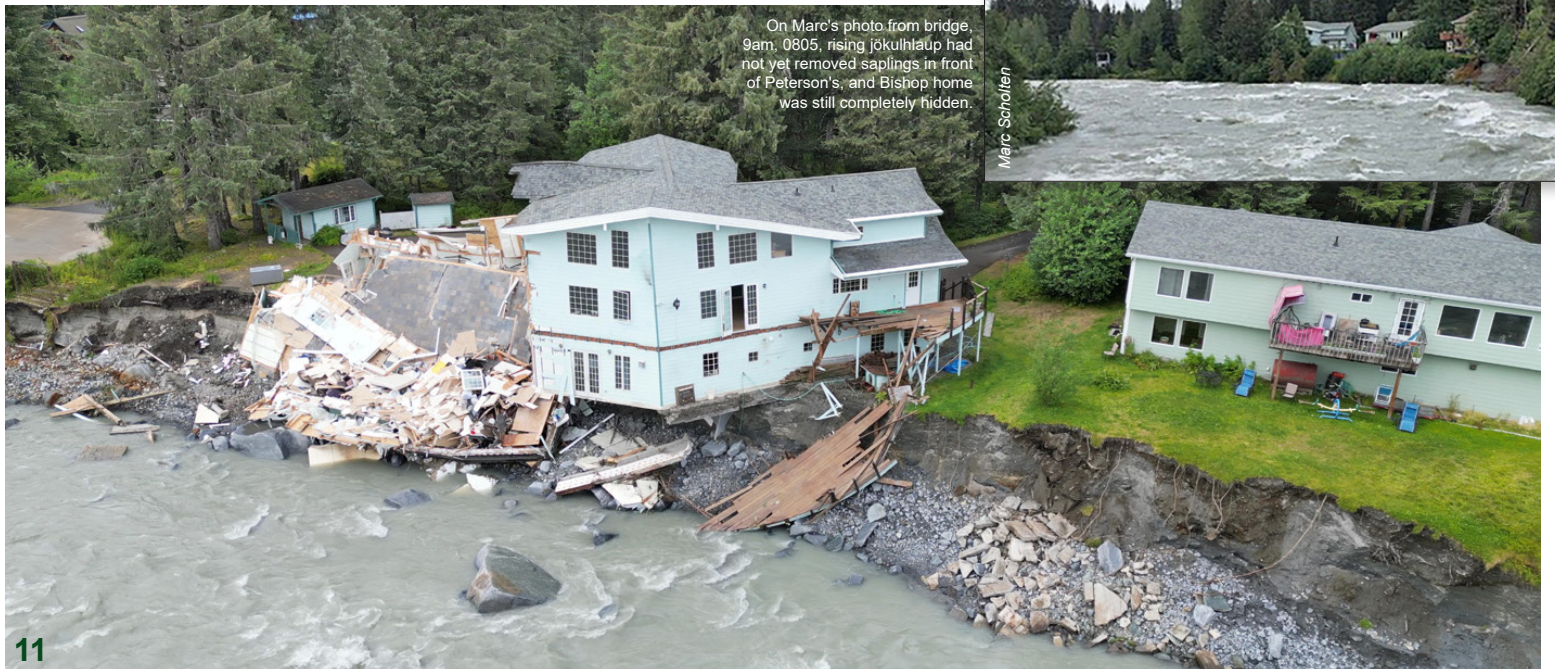
**11 Petersons'** Alluvium's great for lawns, but the river who bequeathed it sometimes wants it back. Imagining peak floodstage against these obliques, you'd picture it nibbling up at lawn level. But on Nolan's Kent-house timelapse, it never reached much higher than base of alluvium.

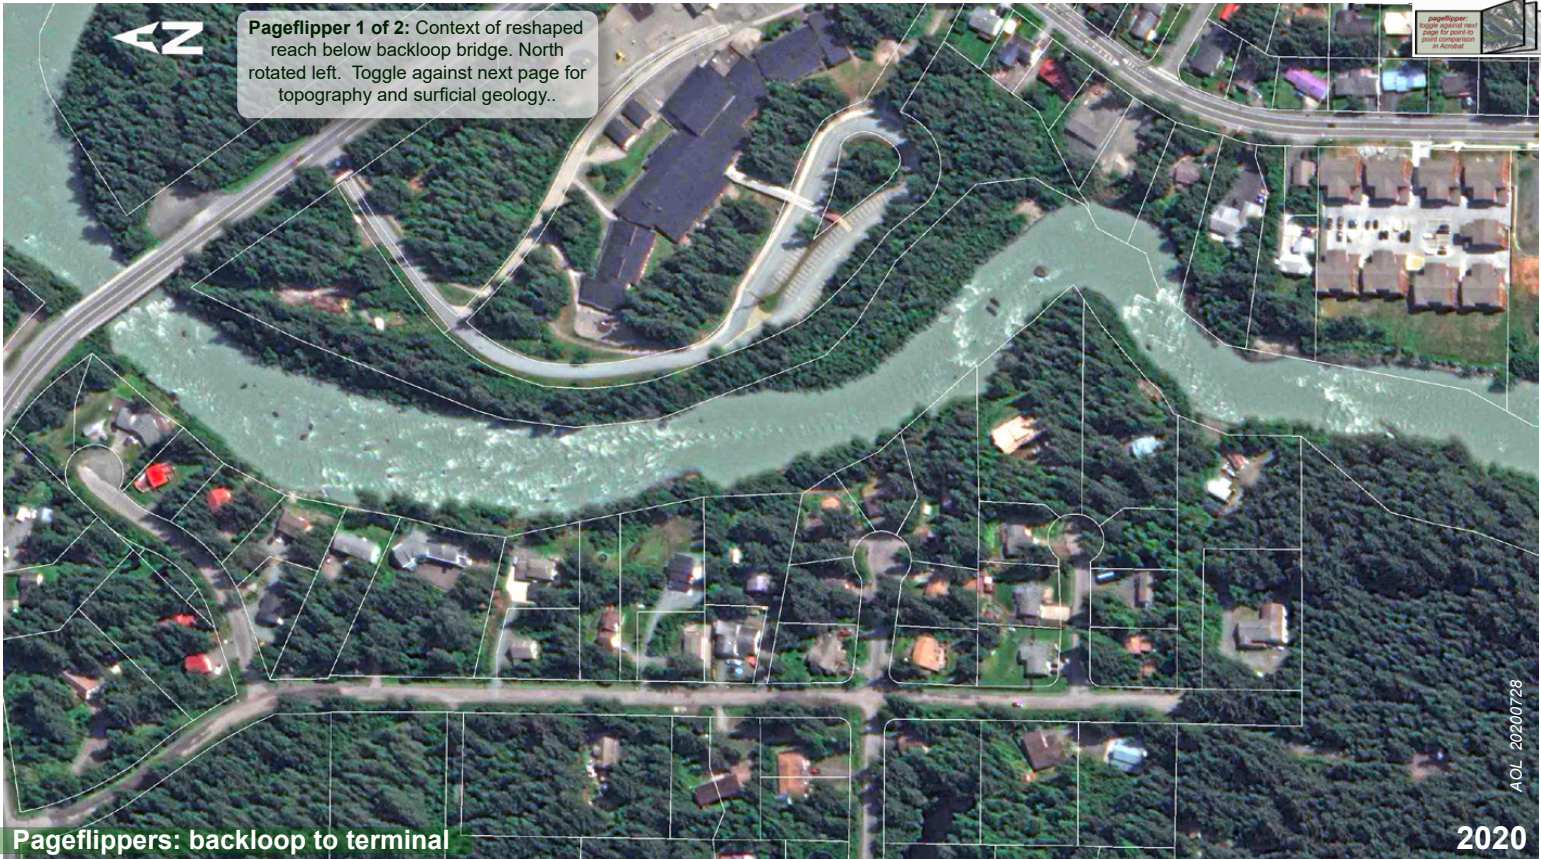
AOL 20200728

Pageflipper 1 of 2: Context of reshaped reach below backloop bridge. North rotated left. Toggle against next page for topography and surficial geology..

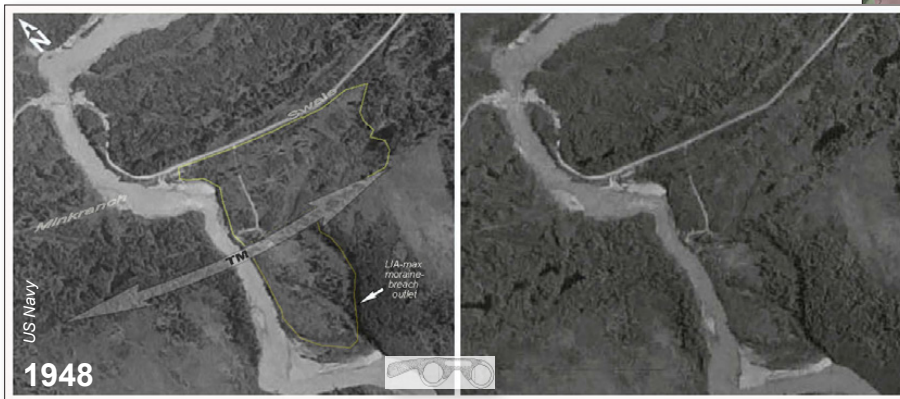
**Pageflipper 1 of 3:** Okay, we're back to north-up on these right-side flippers—focusing on Kent house & Riverside Condos. Toggle against following bare-earth (pre-site-leveling) to see how this section looked before the flood rearranged things. ●

Developer of Riverside Condos applied to the City to clear off his trees, presumably in order to armor the bank, then only ripped bottom corner.

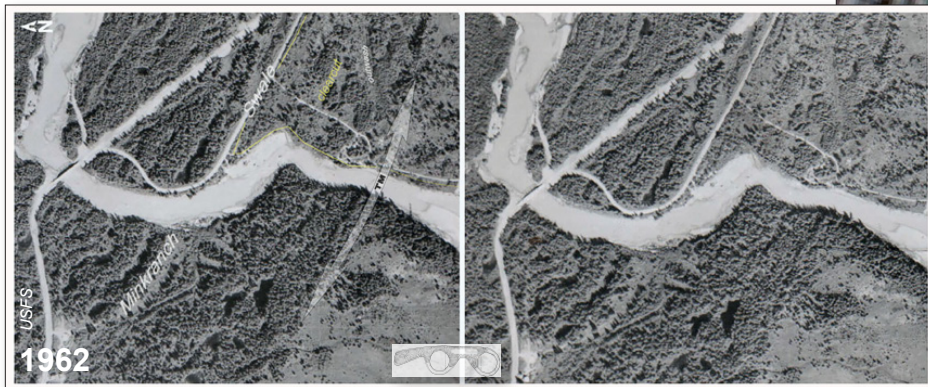
**Pageflipper 2 of 3:** 500 yards downriver from Nate's, 3 riffles in overlaid ortho form over morainal step-downs where the bed drops 3 feet at 3% grade, then nearly flattens. • The Kent house (red) was 23 feet above this June 2013 river level. Timelapse shows that our 20230805 outburst only had to climb halfway, to maybe the 45-ft contour, to undermine alluvium back to my estimated cut line.

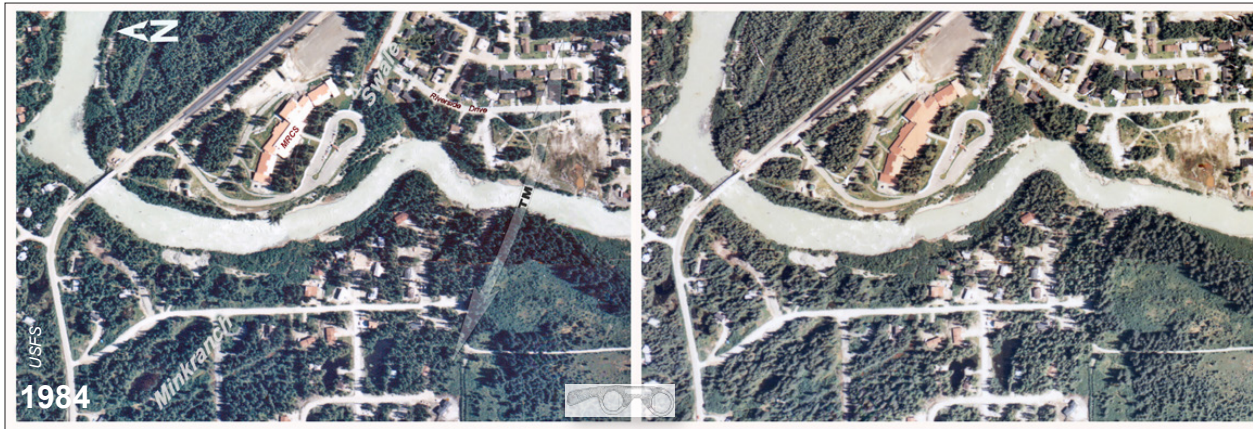
**1984 stereo** Our first high-resolution color imagery for Áak'w Táak (M-word Valley) was shot just after construction of MRC. Traveling north over the section labeled 'Riverside Drive,' you *don't* rise and fall over a series of progressively younger rib-moraines, as you would to the west across the river. The land gently rises from 46 to 58 feet, then falls toward Minkbranch Swale again at just 50 feet. I've labeled these road-surface contours on [preceding hillshade map](#). Granted, it's on a cut-&-fill gradient that mutes original topography.

But check out this area in 3D on the 84s, above. Pretty darned smooth. There are some isolated bouldery 'nubbin moraines,' still mercifully forested. But nothing linear remains. That's due not only to bulldozers but to patterns of glacial recession. In

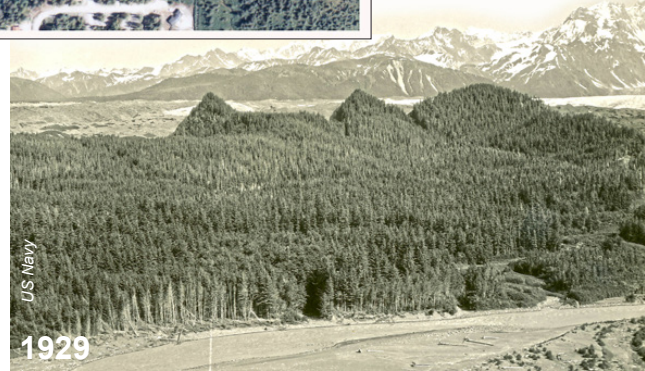
On a much grander scale, the terminal moraine of Tsalḵaan Si'ti, *ground-squirrel-land (Fairweather) glacier* illustrates how once-linear rib moraines are cut&filled into jaggedy 'carnassial-rows.' A similar process may have created the pimply plain at Áak'w Táak's valley-center LIA maximum.

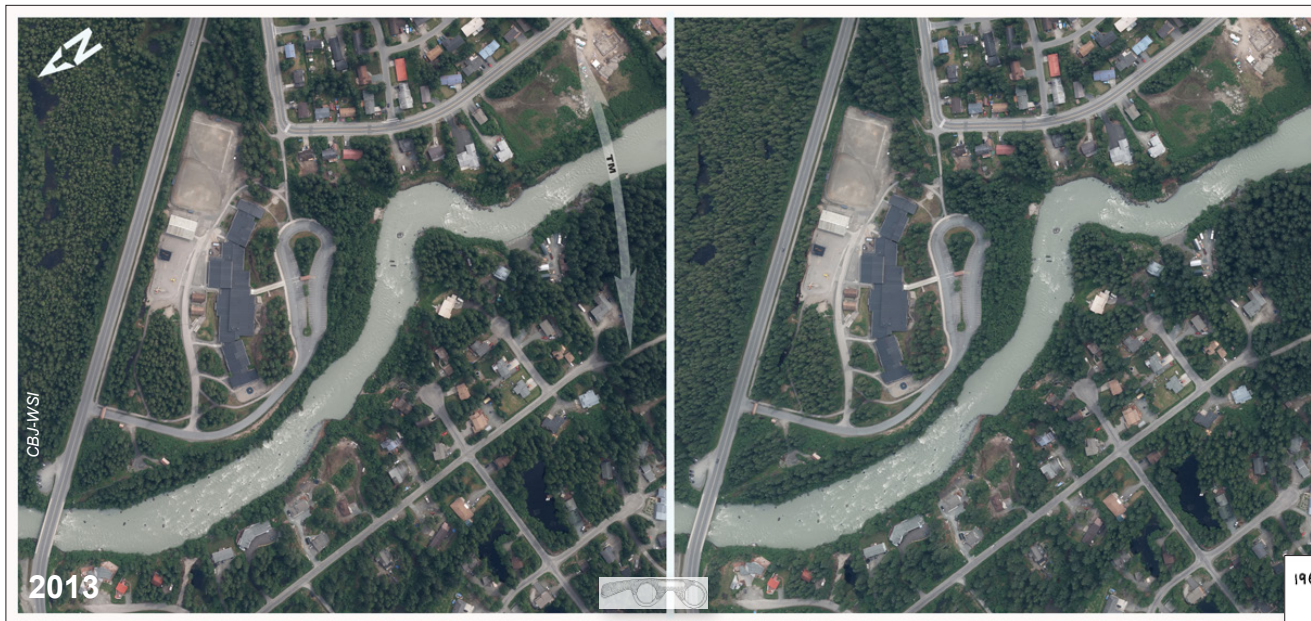
**Below:** 500 yards above Brotherhood Bridge, the river has been an unbraided single channel through loose alluvium and deltaic sand since a right-angle dogleg (palest blue) was first mapped in 1910. I traced this 3-part series in pre-GIS days when the most current photograph was 1996. Outburst in 2018 finally ate through the oxbow neck.

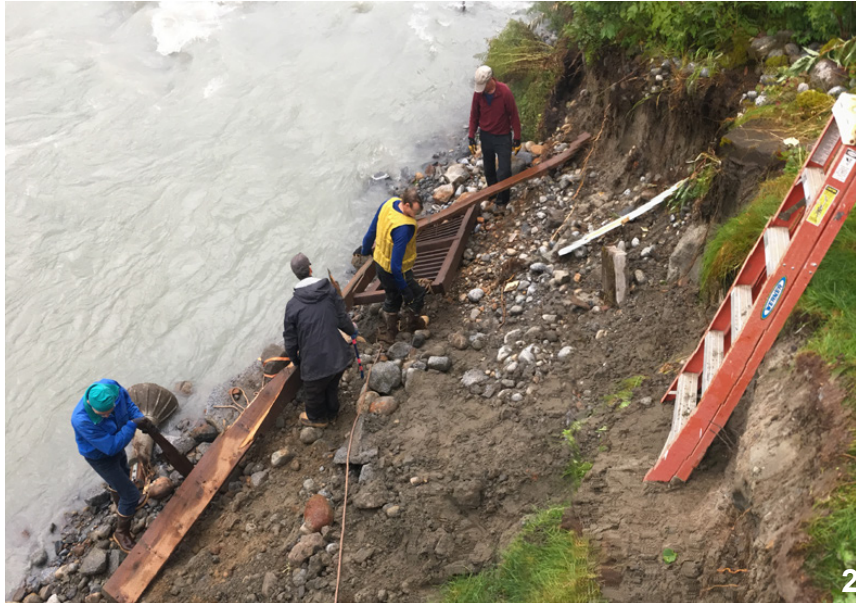
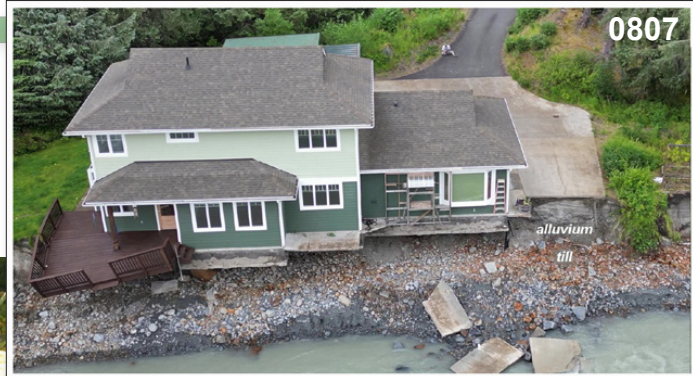
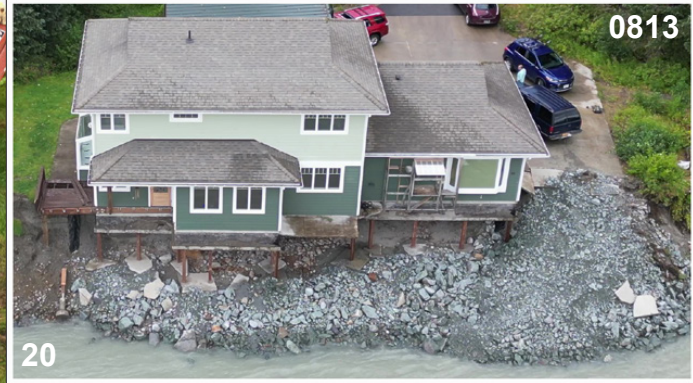
**24 Before & after** Coarse rock has been spread out from the truncated driveway, armoring especially the upriver bank. New posts are based, for now, on cement slabs dropped from the undermined driveway.

Amanda says she's been advised by construction friends on options including skidding the house back from the bank, and teaming with neighbors on a continuous riprap. Prevailing opinion is that fortifying

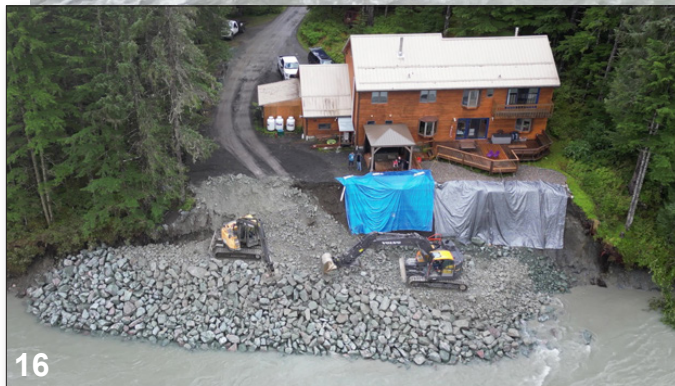
16

**16 Blasco** Boy, there's a lot of earth-moving machinery in this town! And all of it seemed to be bustling around on the riverbanks today. *Bobcat of Juneau* must be raking it in (sorry, pun intended ;) Blascos lost ~30 feet of lawn, outboard of those tarps, and have been fastest and most voluminous at large-boulder placement. All afternoon, a steady parade of dump trucks

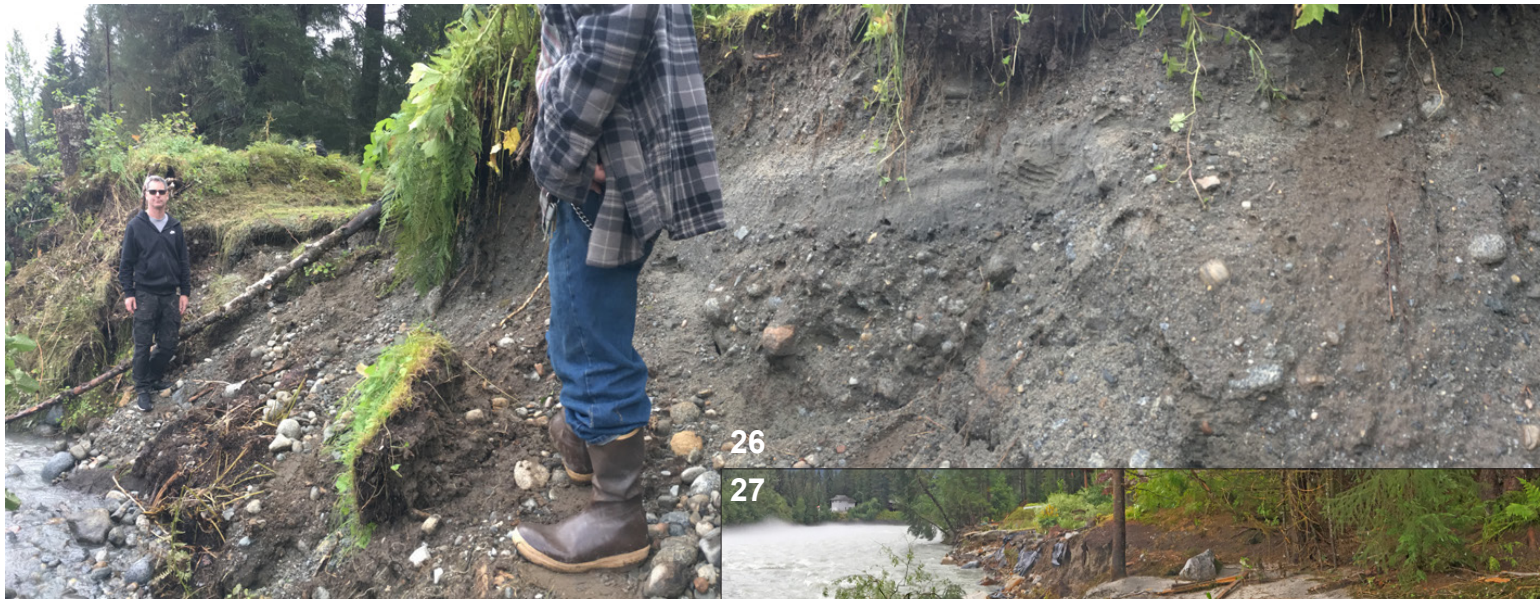
**26 Alain's new bank** When examining this bank I hadn't yet scrutinized the reach on pre-jökullhlaup aerials. So I was shocked when Alain showed me a video of his niece romping around on the yard, far to the left of this pano at about the level of his shoulders.

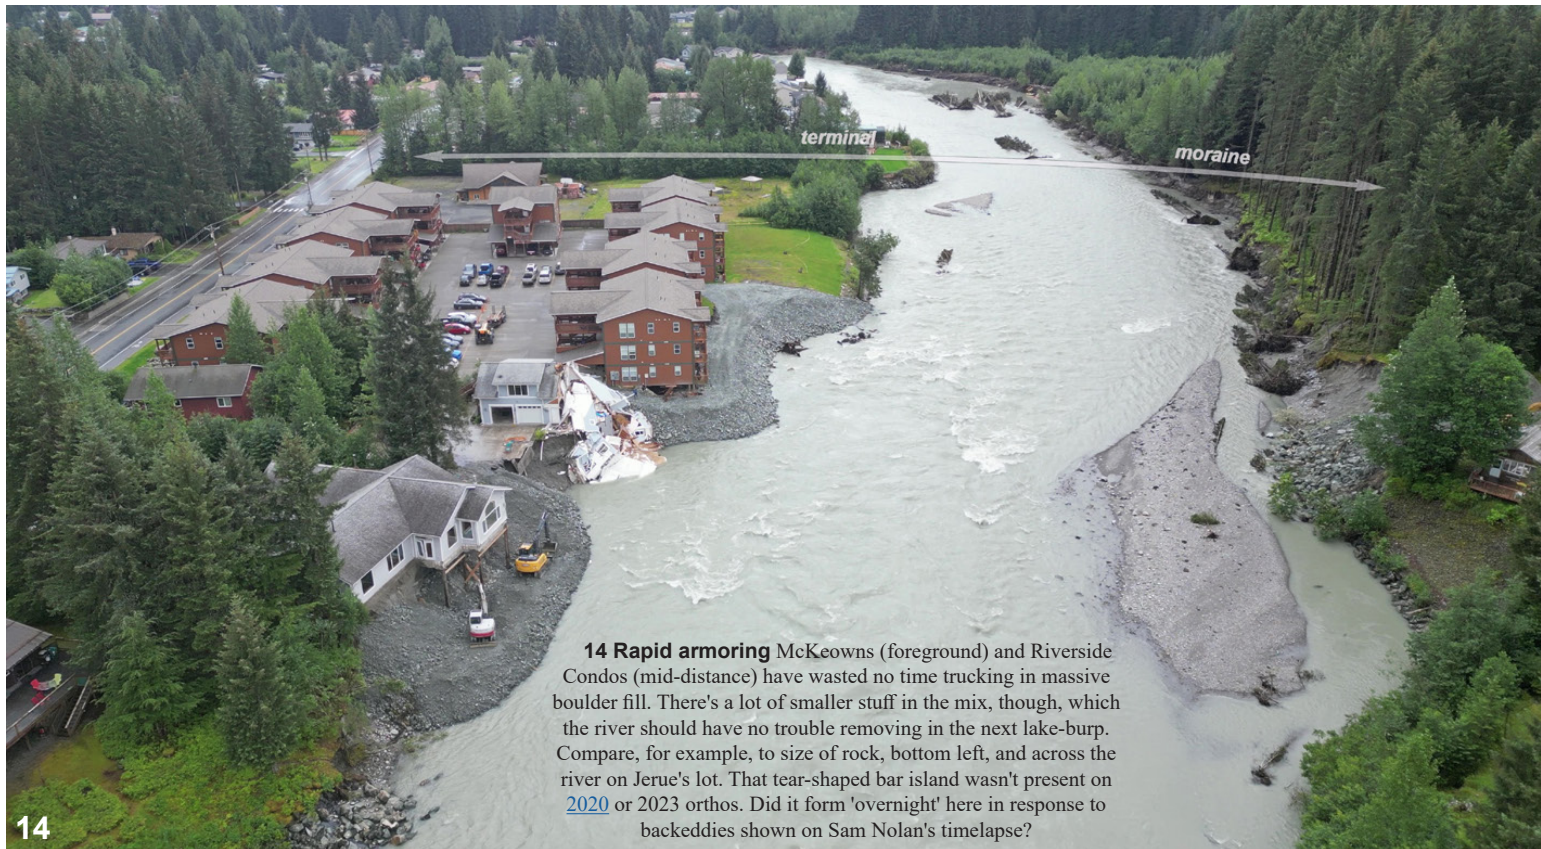
14

**14 Rapid armoring** McKeowns (foreground) and Riverside Condos (mid-distance) have wasted no time trucking in massive boulder fill. There's a lot of smaller stuff in the mix, though, which the river should have no trouble removing in the next lake-burp. Compare, for example, to size of rock, bottom left, and across the river on Jerue's lot. That tear-shaped bar island wasn't present on [2020](#) or 2023 orthos. Did it form 'overnight' here in response to backeddies shown on Sam Nolan's timelapse?

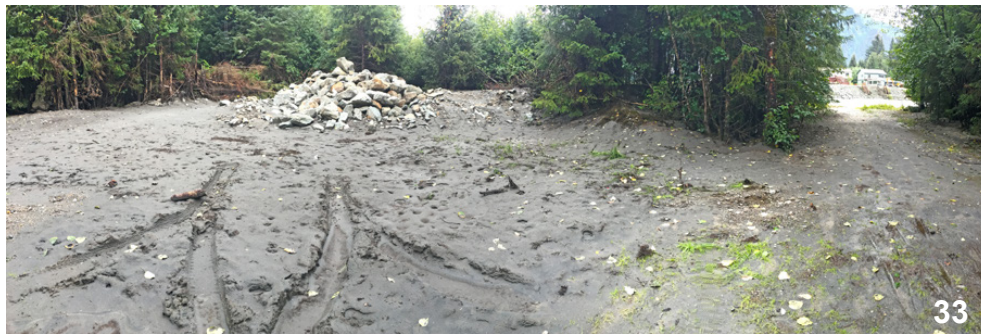
**33 Overbank sand** At peak flow on 0805, floodwaters reached the back edge of Kaiser quarry, about 6 feet above current highflow level and ~250 feet west. Paul investigated some debris washed up into the alder-fringe that appeared to be recent. So while this soupy sand may have been dropped during the mollified ebb, at some point currents were really booking through this last little gap in the alders.

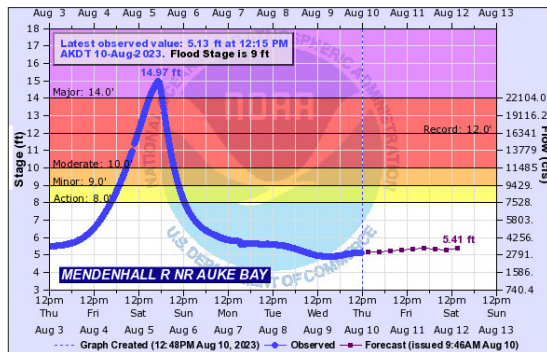
NWS's [page for Mword River](#) on 0810 charted what we might name the 15-ft "*affliction stage*" 5 days prior, way above their threshold "*flood stage*" of only 9 feet. Gage values on left, volume-per-second on right.

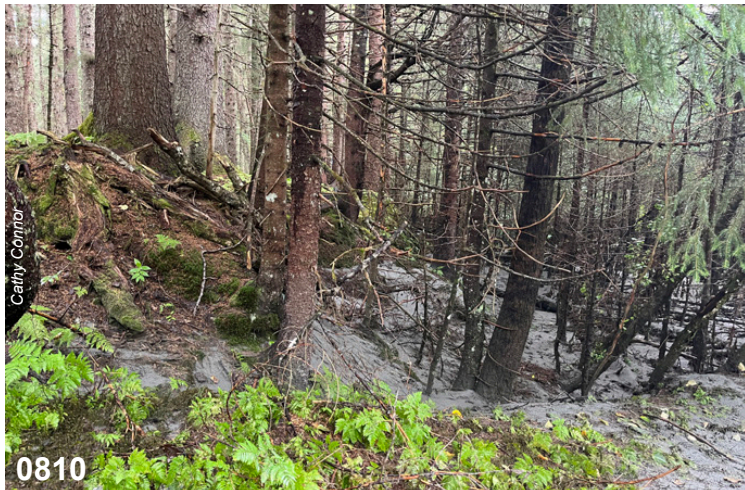
**1948 Dredge Swale** Intermorainal outwash channels tend to be abandoned suddenly, when recession over glacier-rumpled terrain creates new outflow emergence points, or diverts existing ones. High-energy floodplains free of sluggish-water fines are great places to dredge up sorted sand and gravel for the roads and first subdivisions that began to proliferate, mid-century.

Dredge (obviously) and more evasively-named Crystal Lake were both excavated from such swales. By 1948, Dredge had been dredged but Crystal, next swale north, had not. Draining flow through Dredge Swale probably ceased a decade before this photo, but at annual high flow, it was likely backwatered from new N-S flowpaths coming out of nascent Sit'áa (M-word Lake). My 1929 scale-out view, next page, gives east-valley context.
