Artists' conception of apartment complex, superimposed onto runout of path-7 on CBJ's 2013 LiDAR point cloud.

20231220 Runout apartments

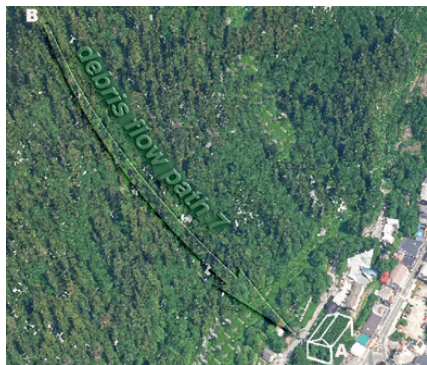
and dogs. (She snickers at humans on anything $>40^\circ$.) In path-3, only the flying tree's launching cliff exceeded 55° .

Comparing lower reaches of path-3 to path-7 on these transects, there's a greater distance of moderate slope on path-7, only $\sim 33^\circ$, where smallish debris flows could come to rest before reaching the proposed apartments. ² That's small comfort in view of Wrangell's mudslide, which ran the last 500 yards at only $\sim 10^\circ$, or the Beach Road slide (BRLS) in Jilkoot Aani, at $\sim 10^\circ$ for the final 300 yards. Crest of the Wrangell slide was at about 1,400 feet, versus 860 feet for BRLS. Does that partially explain the lengthier shallow-slope carry at Wrangell? ³

My previous historical series for last autumn's house-crunching debris flow in path-3 included a point-cloud profile, carried over here at scale, for comparison with the much higher and steeper path-7. Profile A-B runs SW to NE from proposed apartments up and over onto Wooshkeenax Deiyyi, trails above each other (Mt R-word trail).

Profile A-B doesn't show the steepest part of path-7's headwall, so I've added north-south profile C-D, with almost sheer faces up to 70° degrees. For context, the Dept of Fish & Game considers anything $>55^\circ$ to be terrain where Jánwu, *mtn goat*, feels safe from wolves, bears

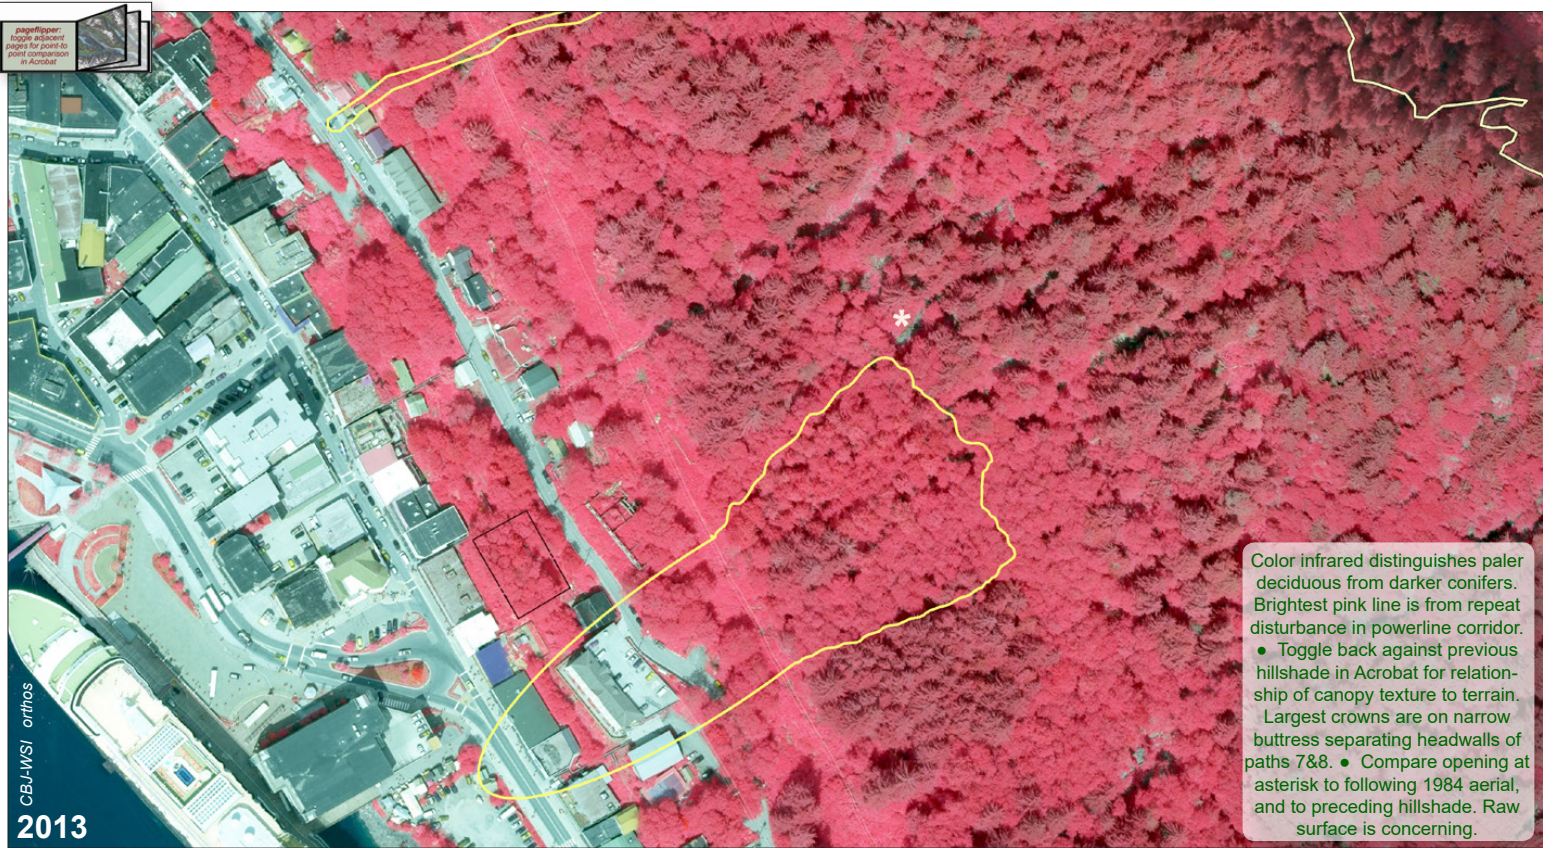
CBU-WSI orthos

Color infrared distinguishes paler deciduous from darker conifers. Brightest pink line is from repeat disturbance in powerline corridor.

- Toggle back against previous hillshade in Acrobat for relationship of canopy texture to terrain. Largest crowns are on narrow buttress separating headwalls of paths 7&8.
- Compare opening at asterisk to following 1984 aerial, and to preceding hillshade. Raw surface is concerning.

² Canopy gaps exposing bare soil on following 2013 and 1984 panels suggest these episodic slumpings are already occurring near the top of the runout apron.

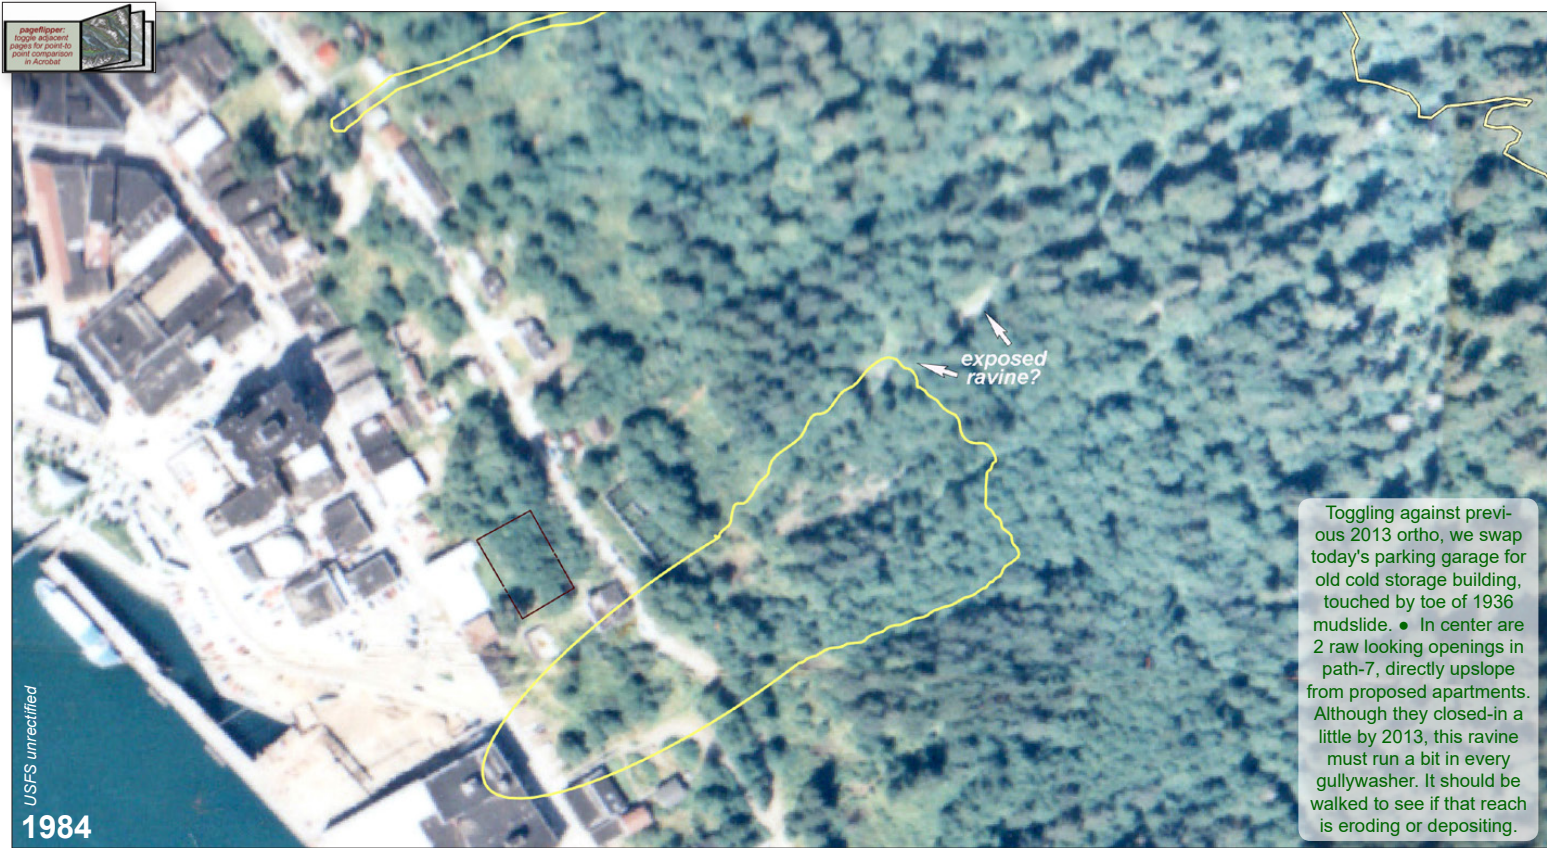
1984

USFS unrectified

exposed ravine?

Toggle against previous 2013 ortho, we swap today's parking garage for old cold storage building, touched by toe of 1936 mudslide. • In center are 2 raw looking openings in path-7, directly upslope from proposed apartments. Although they closed-in a little by 2013, this ravine must run a bit in every gullywasher. It should be walked to see if that reach is eroding or depositing.

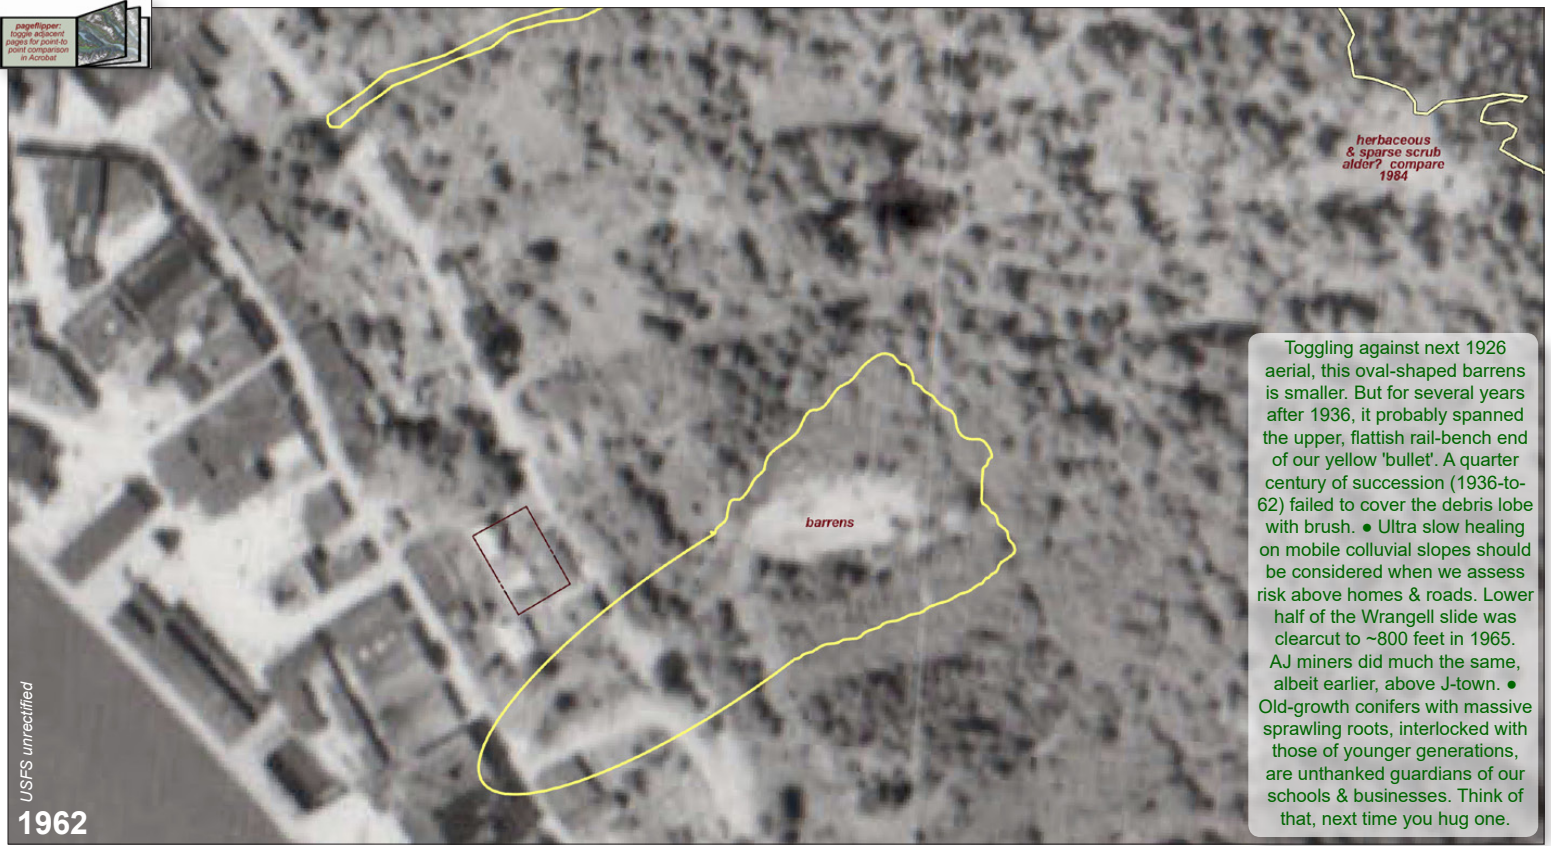
1962

herbaceous
& sparse scrub
alder? compare
1984

barrens

Toggle against next 1926 aerial, this oval-shaped barrens is smaller. But for several years after 1936, it probably spanned the upper, flattish rail-bench end of our yellow 'bullet'. A quarter century of succession (1936-to-62) failed to cover the debris lobe with brush. • Ultra slow healing on mobile colluvial slopes should be considered when we assess risk above homes & roads. Lower half of the Wrangell slide was clearcut to ~800 feet in 1965. AJ miners did much the same, albeit earlier, above J-town. • Old-growth conifers with massive sprawling roots, interlocked with those of younger generations, are unthanked guardians of our schools & businesses. Think of that, next time you hug one.

USFS unrectified

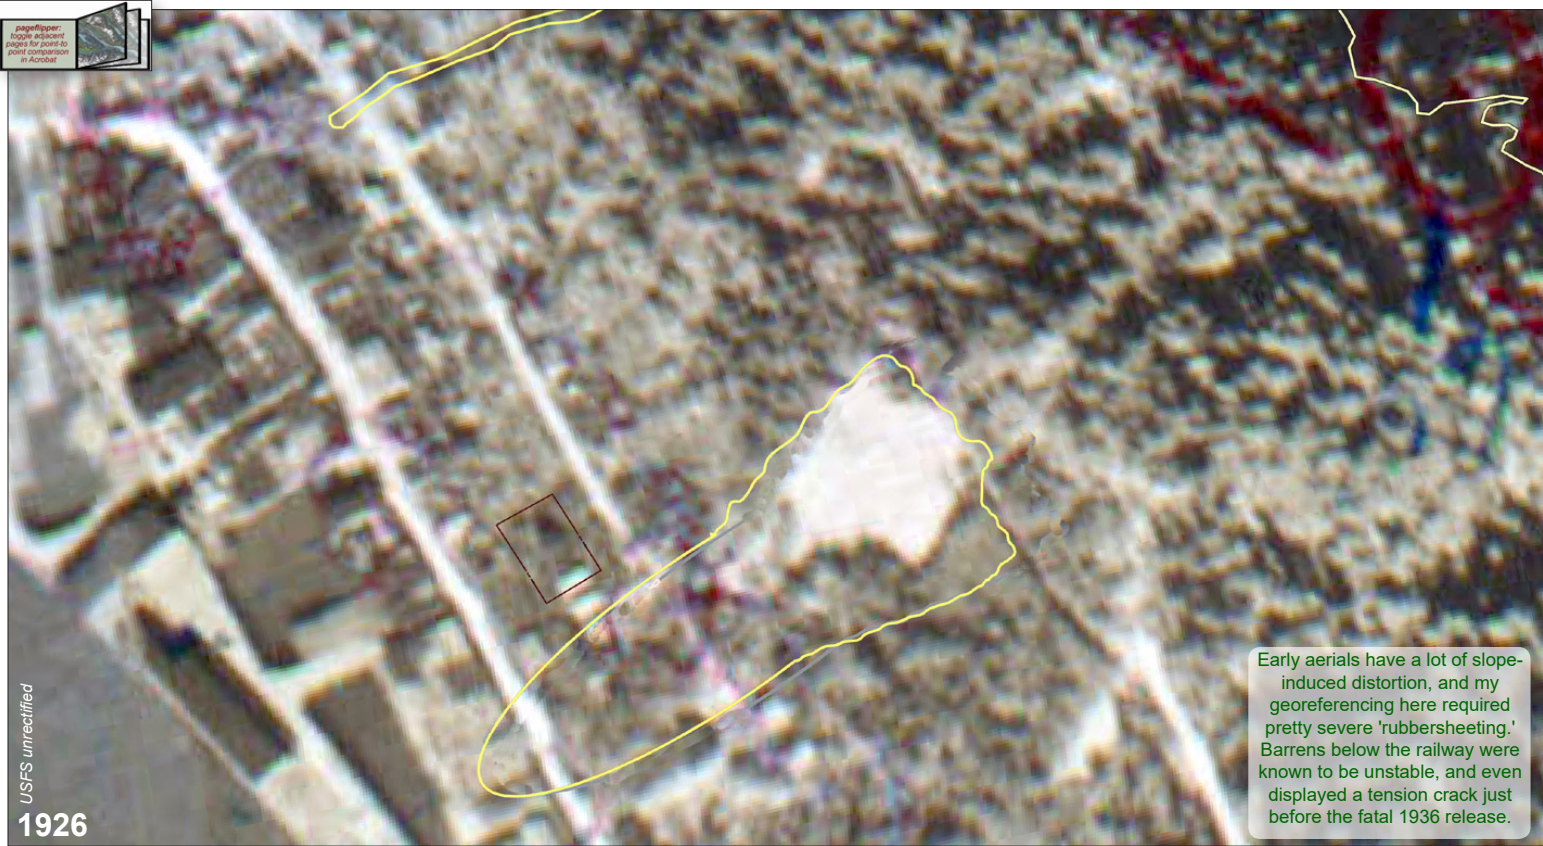
1926

USFS unrectified

Early aerials have a lot of slope-induced distortion, and my georeferencing here required pretty severe 'rubbersheeting.' Barrens below the railway were known to be unstable, and even displayed a tension crack just before the fatal 1936 release.

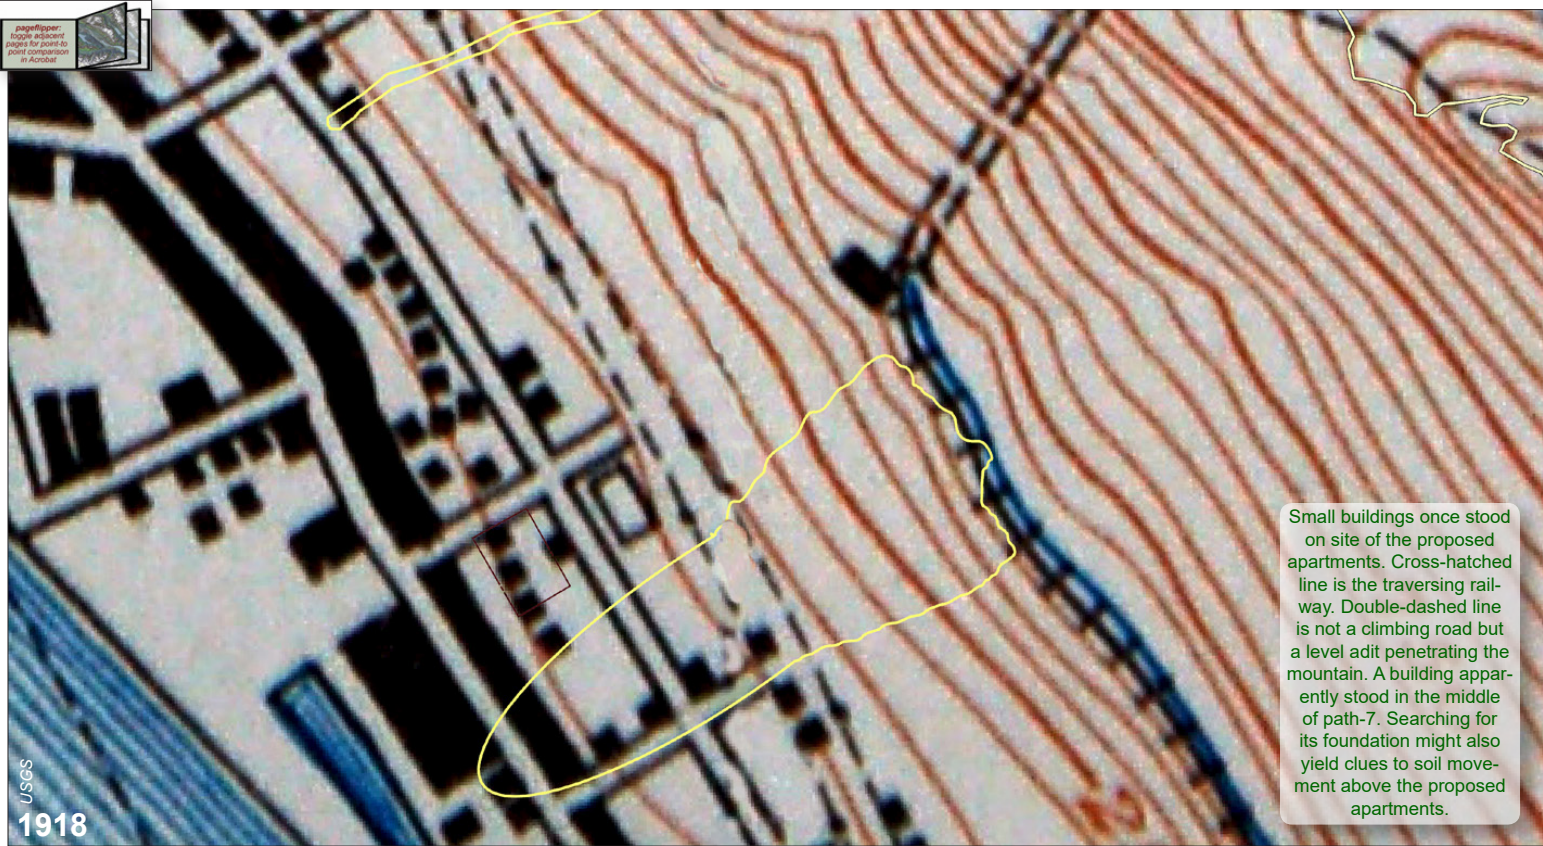
1918

USGS

Small buildings once stood on site of the proposed apartments. Cross-hatched line is the traversing railway. Double-dashed line is not a climbing road but a level adit penetrating the mountain. A building apparently stood in the middle of path-7. Searching for its foundation might also yield clues to soil movement above the proposed apartments.
