20231204 Wrangell mudslide

It's taken awhile to get around to mapping this one, but curiosity finally led me to my rather limited GIS resources for the fatal Nov-20 landslide south of Pat's Creek. Many similarities to the Chilkat's 20201202 BRLS (*Beach Road Landslide. Awesome UAF [storymap](#) was posted this May.*

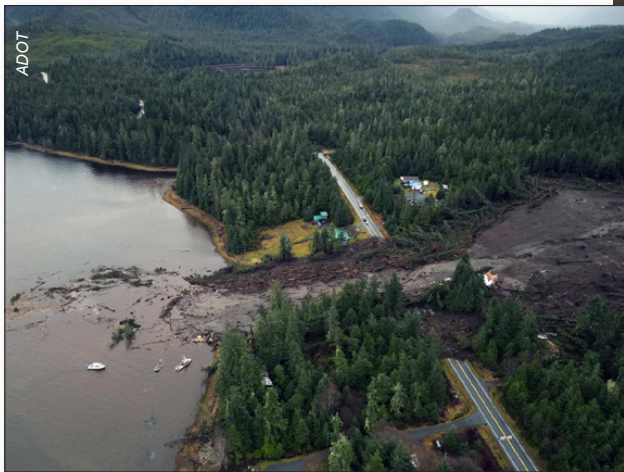
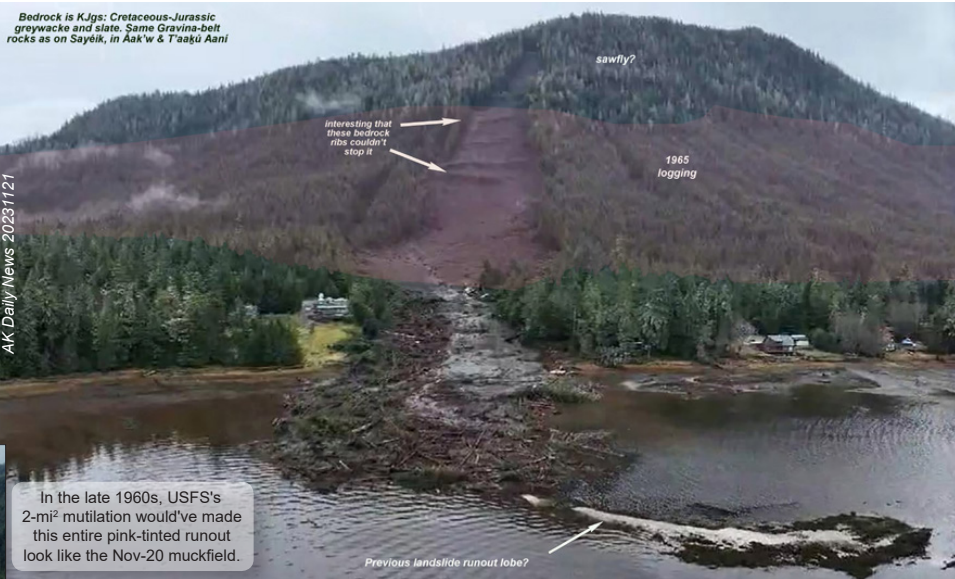
Photo on right was taken the day after. Articles claim 450 ft wide at the road, but arc suggests maybe 380. *Very* crude eyeballing on next page indicates top is ~0.7 miles from beach, crowning at ~1,400-foot contour.

In the late 1960s, USFS's 2-mi² mutilation would've made this entire pink-tinted runout look like the Nov-20 muckfield.

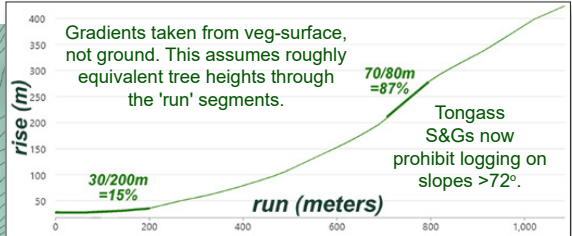
IfSAR has 5-m pixel resolution. Too coarse to model the little crescent (debris lobe?) on flipper but was apparently flown at low tide.

lumpiness is vegetation surface, not ground

quickly eyeballing; very approximate

So far, no vertical aeriels of path, so everything is 'eyeballed' from obliques. Best elevation model is IfSAR DSM (DTM is 'smushed' & useless.) ¹ Creek on bottom edge *appears* to run down a bulge, only cause this is a **canopy** model from high-hits on foliage; trees are taller there. Steepest part of path is 87%, and runoff averages just 15% slope.

I'd never have predicted a mud slide on this 'shoulder' or convexity; seems like funneling swales & concavities should run sooner.

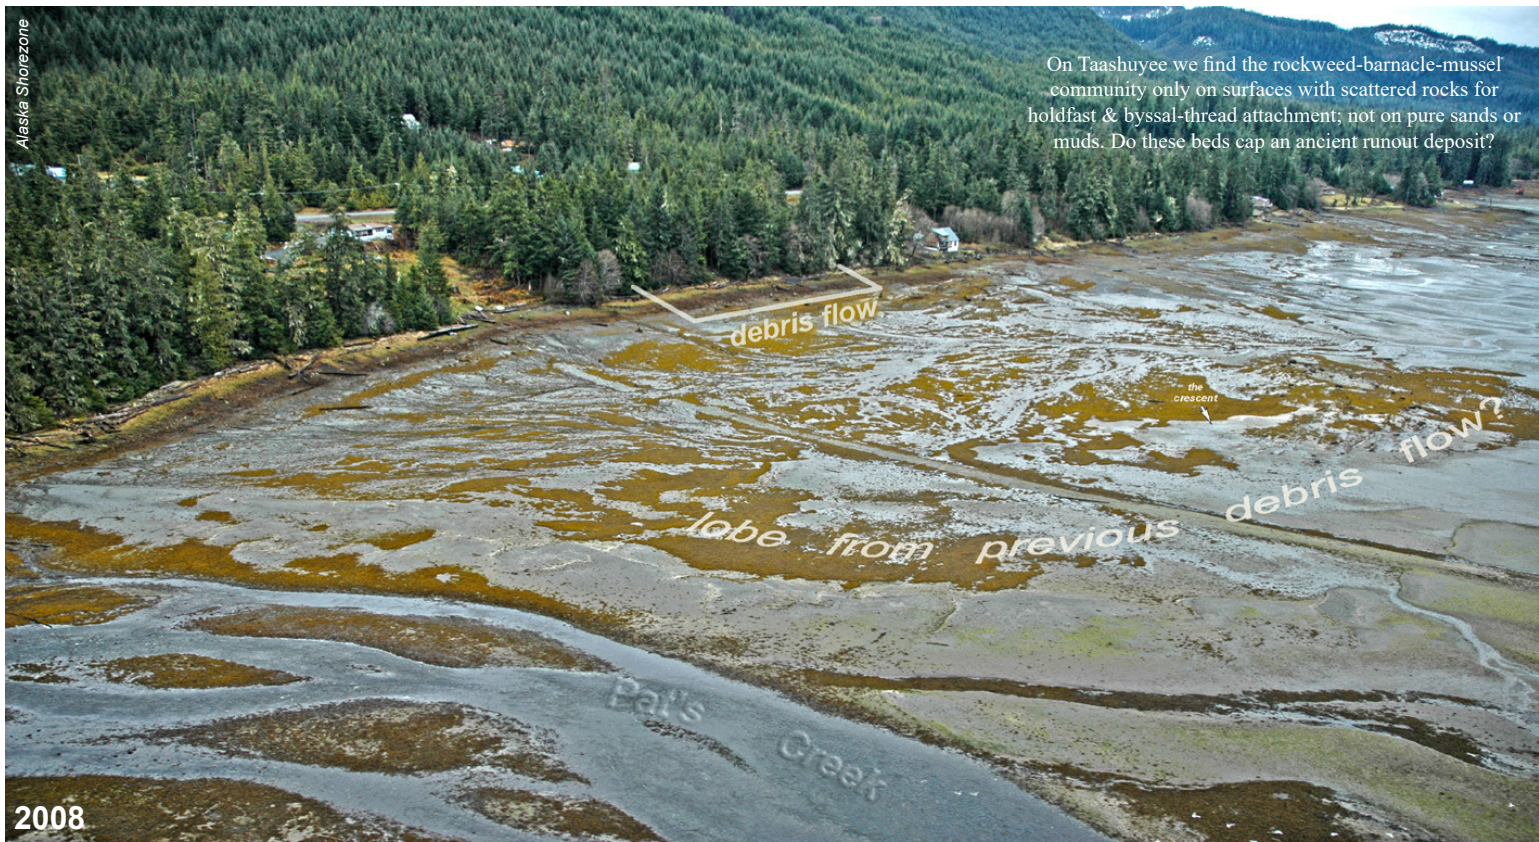
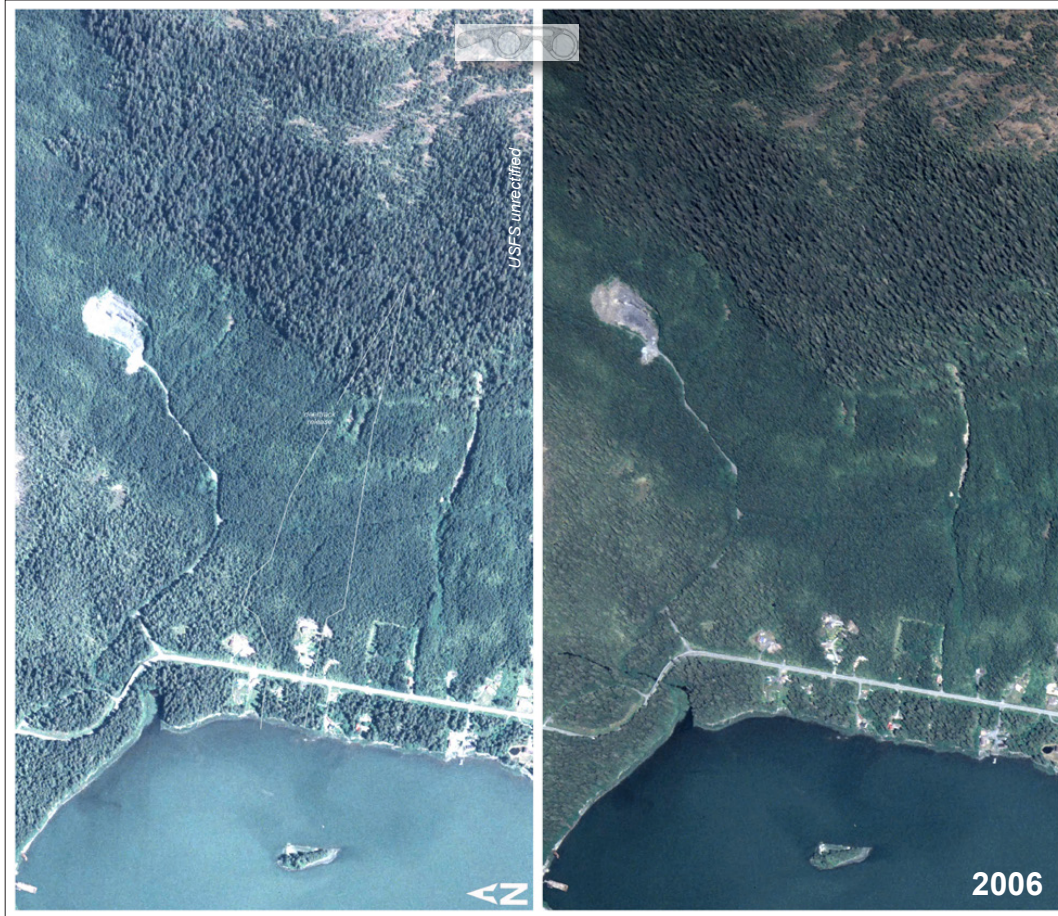
2008

3D context FS Geometronics gave me the raw, pre-rectified .jp2 collections for 2006, 07 & 08, higher res than the disappointing orthomosaic tiles released a few years later. They're handy for assembling these stereopairs.

I used to have a pretty complete collection of 1970s as well, which would show the megacut before canopy closure. It'd be nice, for example, to know if the 'deertrack' scar developed immediately after or during logging. But this stretch of beach didn't turn up in the few "*resource-photography*" missions I still possess. Jacob Hoffman's wonderful collection of pre-logging 1960s by FS and the mills has parts of Wrangell Island, but again, no dice for this area. Next-best, for a time-machine visit to pre-logging, pre-coast-road yesteryear, is the Navy's 1929 aerials on next page.

Even dialing back to these 2006 aerials, succession in the 'deertrack' looks fairly advanced. I'll bet it dissolved a little every time we got a 2-day gully-washer, enough to retard healing indefinitely. We may never sleuth out which part of the November-20 slump triggered first. But one scenario is that the deertrack collapsed, which in turn allowed insect-weakened old-growth root systems to unzip, all the way up to the pointed 'crown.'

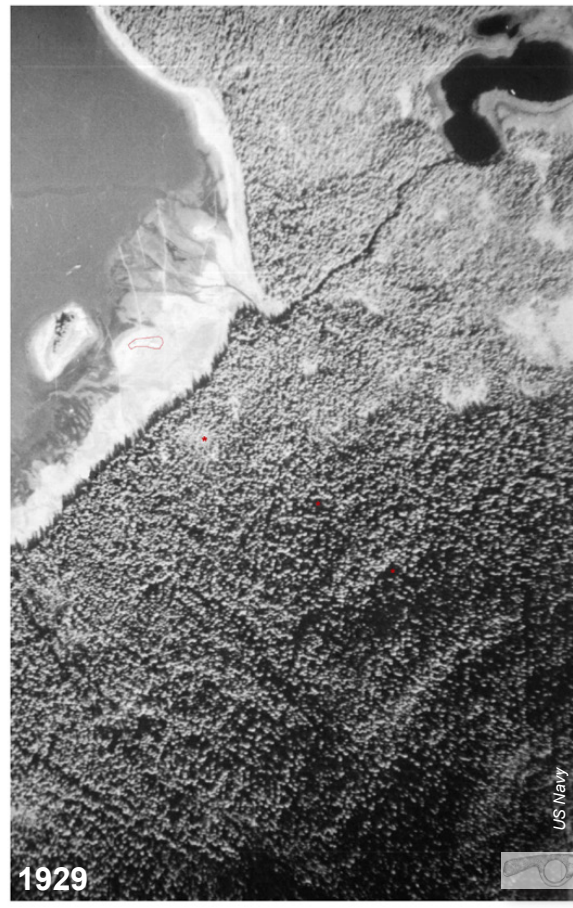
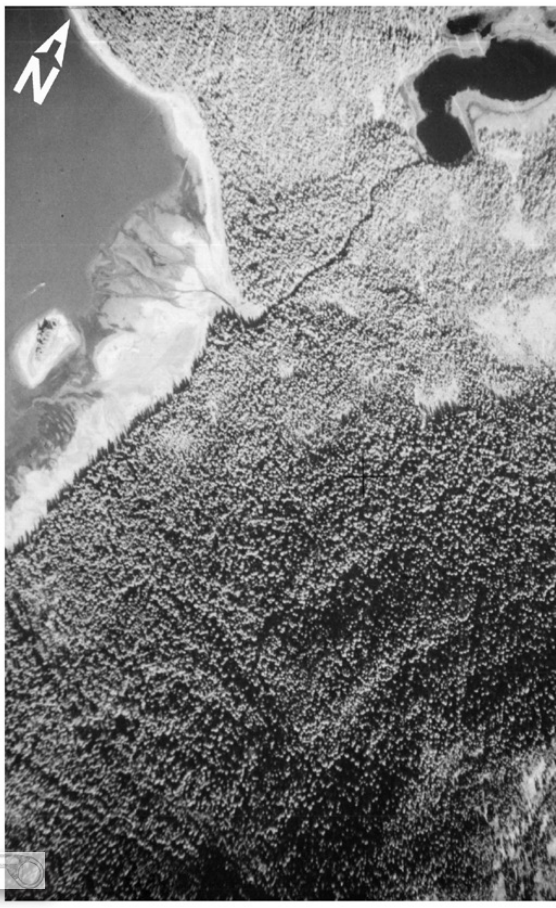
Century ago Lucked out here! Our mudslide falls entirely in the central, nadir portion of the Navy's 'butterfly-bandage' tri-lens aerials, so distortion and illusory tree-lean is minimized.

However, there aren't enough reference points to attempt an outline of our 2023 path, as on the 2006 pair. We can only start at that red-circled postulated debris-lobe, and trace the fall-line upslope from there.

Climbing, we pass first through a bench with open peatland (red asterisk), probably on marine-terrace fines. Hard to reconcile that with the debris lobe, unless the slump happened at higher sea level, before bench-fines finished building. That pushes back both debris lobe and bog to early Holocene. Any landslide the magnitude of 20231120 would've erased that bog. So this slope has been stabilized for >10,000 years.

Upslope, asterisks mark a few small gaps, maybe 3 canopies wide, in the future mudslide path. But nothing trenched or linear, as seen farther southward. Maybe that geriatric old growth wasn't so doddering after all.
